## **2011 Annual Inspection Report**

### **Pass Chaland to Grand Bayou Pass Barrier Shoreline Restoration**

State Project Number BA-35  
Priority Project List 11

February 1, 2012  
Plaquemines Parish

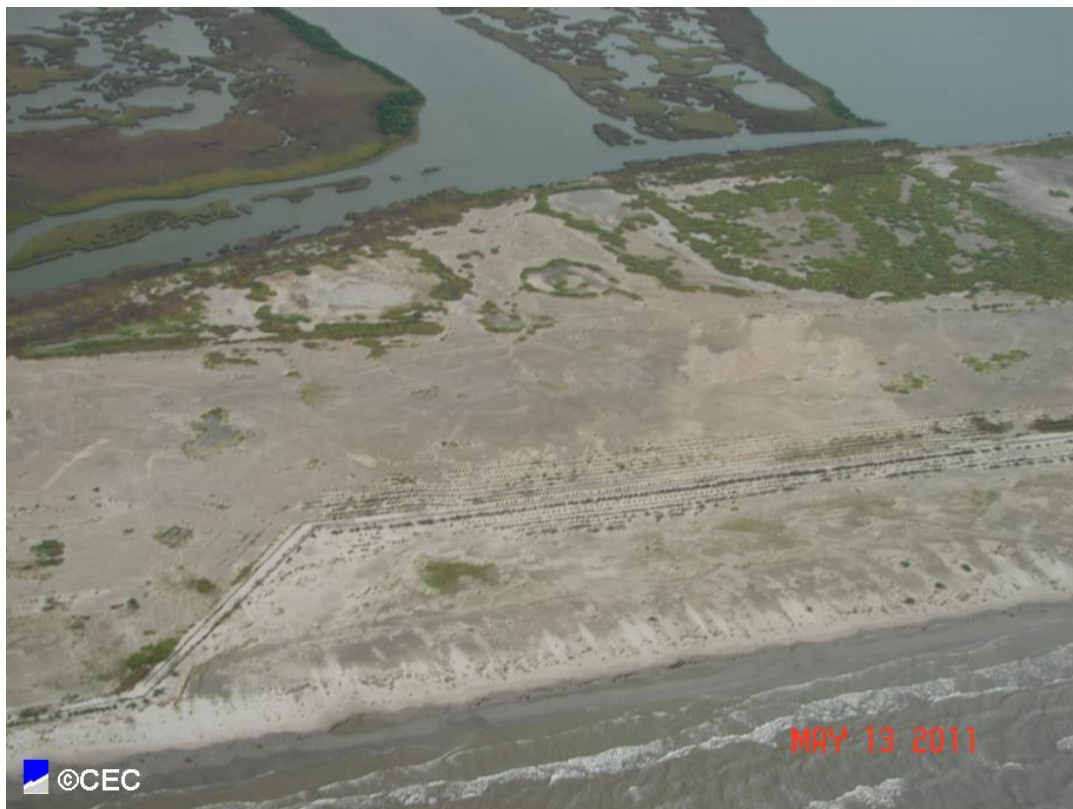
Approximately 14,360 linear feet of sand fencing was installed during project construction. This structure appears to be holding up based on the photographic evidence (Photo #2).

The rows of beach and dune vegetation are visible in the photos; however, it is unclear the status of the plants. It is unknown the effect this year's drought had on the vegetation and whether it has survived through the summer (Photos #2, 3, and 4).

**Photo #2 – Sand Fence and Vegetative Plantings.**

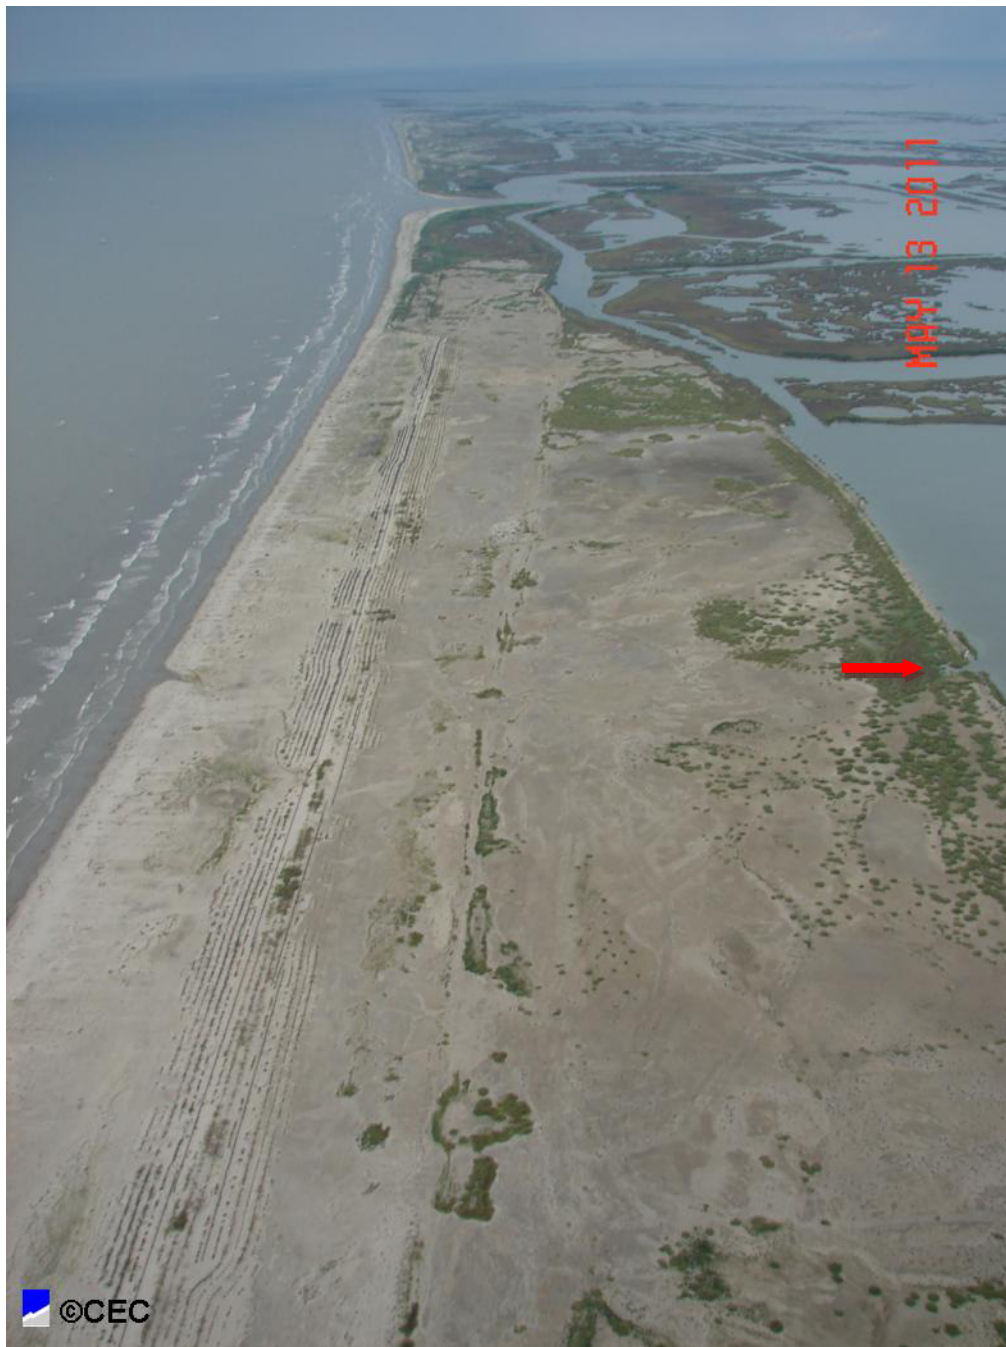
The containment dike was not degraded upon demobilization from the construction site. During the period between demobilization and this inspection the dike has been slowly degrading due to natural processes. At least three gaps are visible in the photos from this inspection (Photos #3 and 4). We note that vegetation is present near these breaches, and water can be seen interior of the dikes near some of the breaches. It appears that limited hydrologic exchange is occurring between the marsh creation area and surrounding waters.

**Photo #3 – Western Dike Breach (arrow) and Degradation and Vegetative Plantings.**

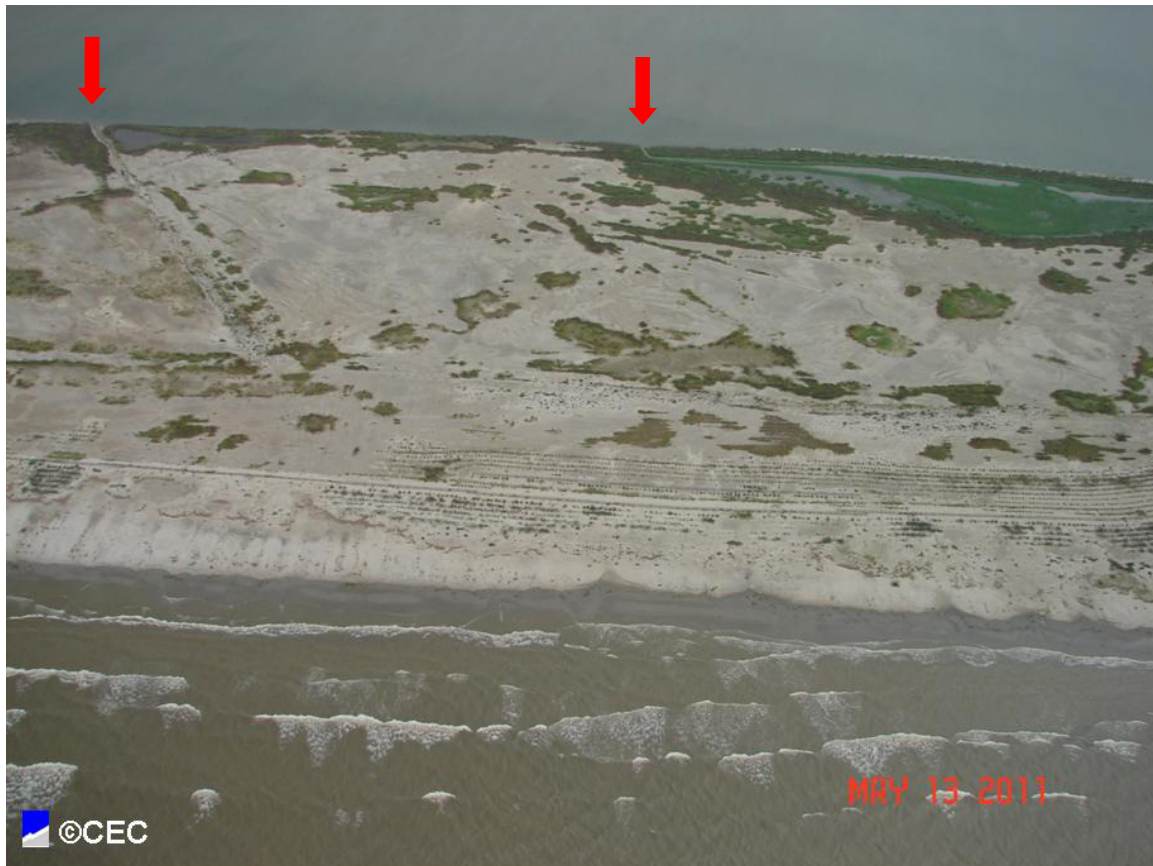
**Photo #4 – Eastern Dike Breaches (arrows) and Vegetative Plantings.**
